CITY OF AVONDALE LARGE DIAMETER SANITARY SEWER  
CONDITION ASSESSMENT & REHABILITATION PROGRAM 2014

Dibble Project No. 101451 | March 2015

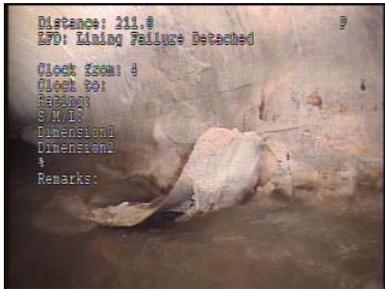
SEVERITY	DESCRIPTION	NASSCO PACP CODE	PHOTOGRAPHIC IMAGE FROM CCTV
Rating  3 Fair	Moderate Defect	LFD Lining Feature Detached

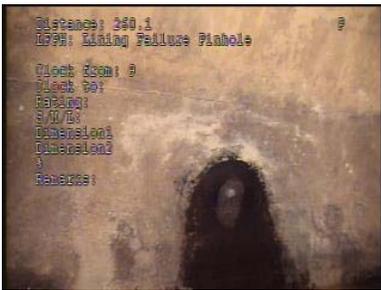
SEVERITY	DESCRIPTION	NASSCO PACP CODE	PHOTOGRAPHIC IMAGE FROM CCTV
Rating  3 Fair	Moderate Defect	LFPH Lining Feature Pinhole

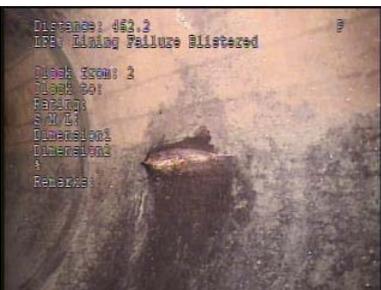
Rating  3 Fair	Moderate Defect	LFB Lining Feature Blistered

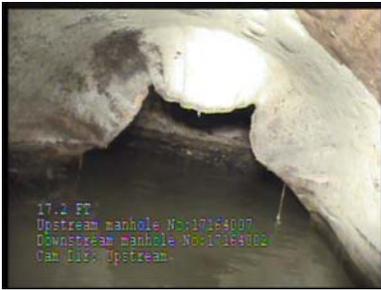
Rating  3 Fair	Moderate Defect	LFD Lining Feature Detached

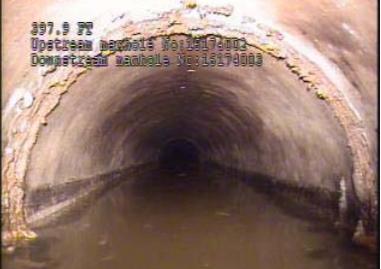
SEVERITY	DESCRIPTION	NASSCO PACP CODE	PHOTOGRAPHIC IMAGE FROM CCTV
Rating  3 Fair	Moderate Defect	LFD Lining Feature Detached

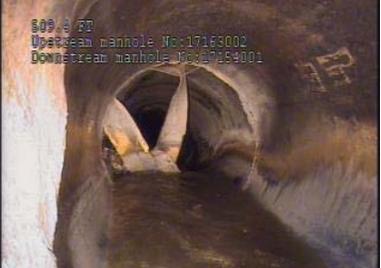
Rating  3 Fair	Moderate Defect	LFD@ Joint Lining Feature Detached At Joint

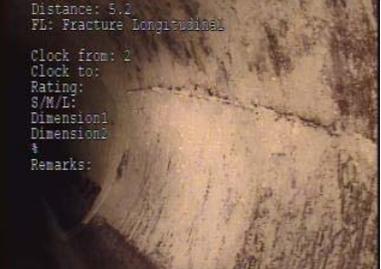
Rating  3 Fair	Moderate Defect	FL Fracture Longitudinal

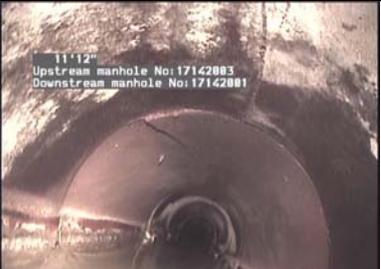
Rating  4 Poor	Significant Defect	FM Fracture Multiple

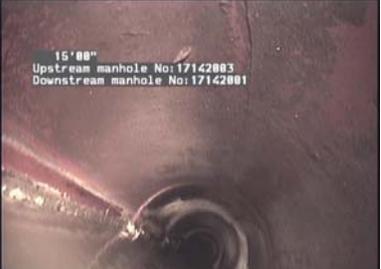
Rating  3 Fair	Moderate Defect	FL Fracture Longitudinal

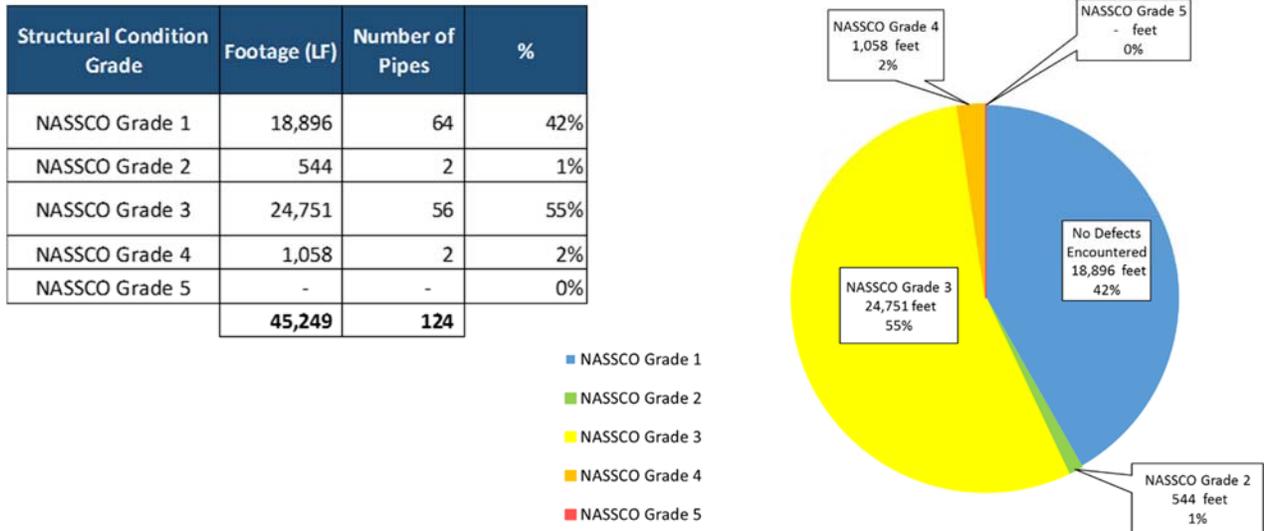
**Figure 3 – NASSCO PACP Structural Condition Grade**

**Figure 3** shows the percentage of pipe by structural condition grade. Approximately 42% of the pipe assessed was found to have no structural defects. Condition Grade 2 defects (“Minor to Moderate”) were found in 1% of the pipe assessed. Condition Grade 3 defects (“Moderate”) were found in approximately 55% of the pipe assessed. Condition Grade 4 defects (“Significant”) were found in approximately 2% of the pipe assessed. None of the pipe assessed were found to have Condition Grade 5 (“Most Significant”) defects. NASSCO PACP structural condition grades for each pipe segment are summarized in **Table A.1** in **Appendix A**.

**Grade 2:** Two of the 24-inch diameter VCP pipe segments assessed for condition were found to have “Minor to Moderate” NASSCO Structural Defects with a Grade Condition of 2. Condition Grade 2 defects are minor in severity and small in size. Deterioration within the pipe is not yet evident.

**Grade 3:** 55% of the pipe assessed for condition were found to have “Moderate” structural defects with NASSCO PACP Condition Grade of 3. The majority of PACP Condition Grade 3 Structural defects noted were lining feature defects within the T-Lock PVC Lined Concrete Pipe including detached PVC Lining, detached joint weld strips, lining splits, lining bulges, and lining pinholes. According to NASSCO PACP, lining feature defects do not have a varied level of severity (i.e. detached lining at the joint has the same severity level as a pinhole). Thus, it is important to look at each of the pipe lining defects noted when assessing the overall condition of T-lock PVC Lined concrete pipe.

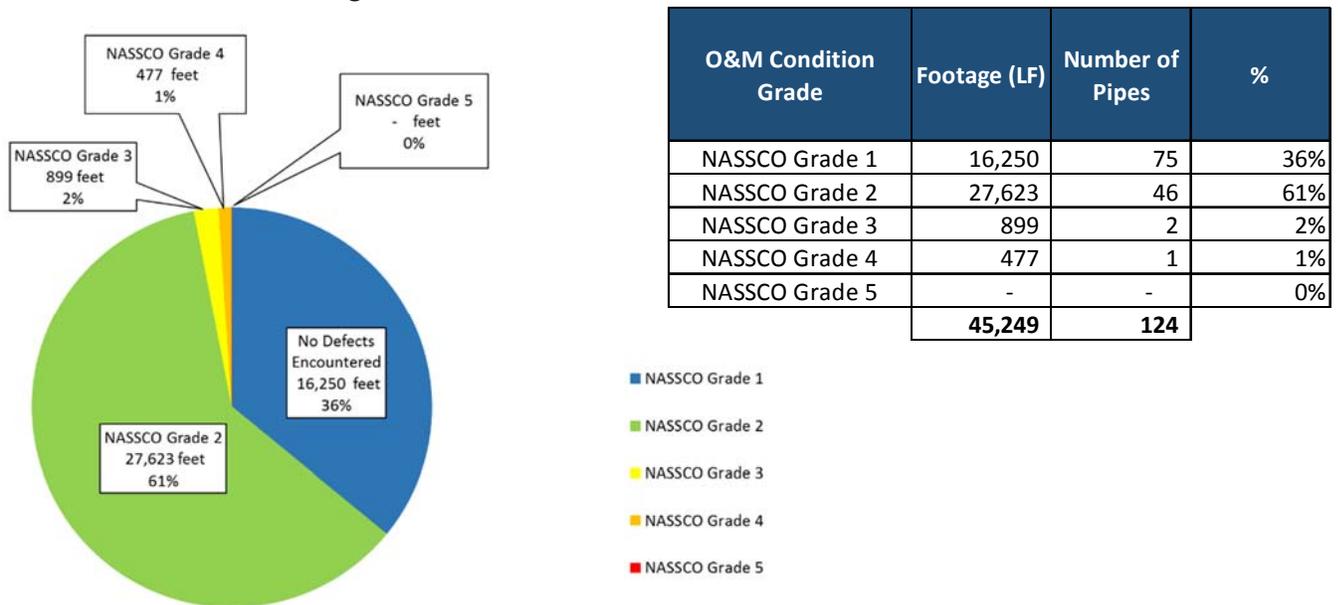
**Figure 4 – NASSCO PACP O&M Condition Grade**

**Grade 3:** Two (2) of the pipe segments assessed for condition were found to have NASSCO PACP Condition Grade defects with severity level of 3. The majority of PACP Condition Grade 3 defects noted were grease or encrustation deposits at the water level.

**Grade 4:** One (1) of the pipe segments assessed for condition was found to have a NASSCO PACP Condition Grade 4 defect. The defect encountered is a large accumulation of attached debris in Pipe Segment SS17163001, located in Van Buren Street, east of Fairway Drive. The accumulation of debris is attributed to a detached PVC Lining Joint.

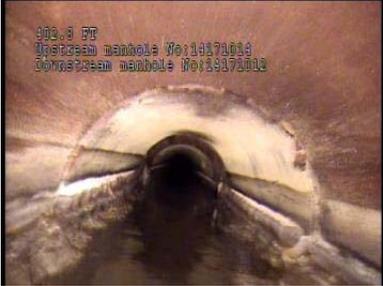
SEVERITY	DESCRIPTION	NASSCO PACP CODE	PHOTOGRAPHIC IMAGE FROM CCTV
Rating  2 Good	Minor to Moderate Defect	DAGS Deposits Attached Grease

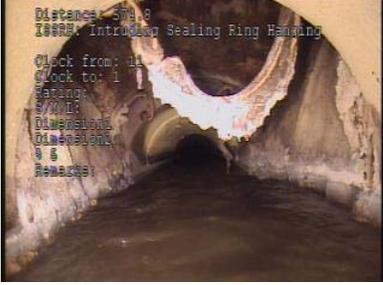
Rating  2 Good	Minor to Moderate Defect	ISSR Intruding Sealing Ring

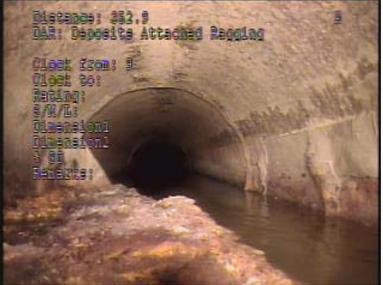
Rating  4 Poor	Significant Defect	DAR Deposits Attached Ragging

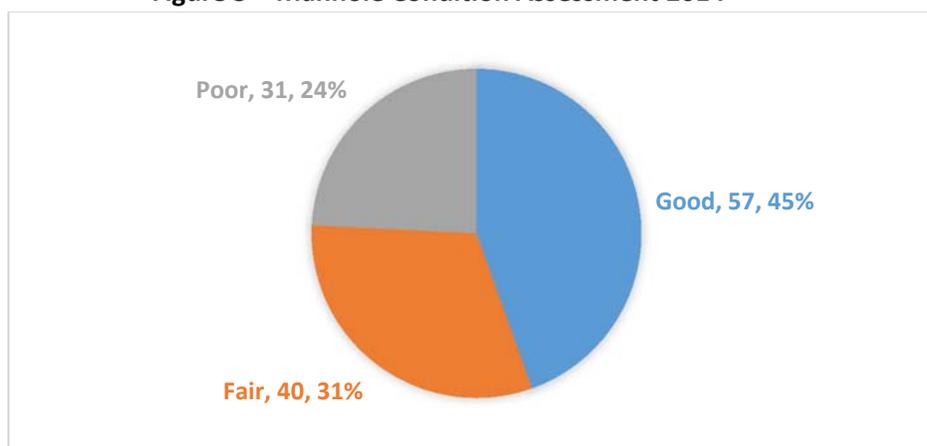
**Figure 5 – Manhole Condition Assessment 2014**

Four (4) manholes were found to have O&M items of possible concern:

- MH16171003 makes connection to the pipe at the 3:00 o'clock position. This manhole could be removed and replaced for as part of the pipe rehabilitation in Project 1E. Project 1E is described in **Section VI Project Summary**.
