CITY OF AVONDALE LARGE DIAMETER SANITARY SEWER  
CONDITION ASSESSMENT & REHABILITATION PROGRAM 2014

Dibble Project No. 101451 | March 2015

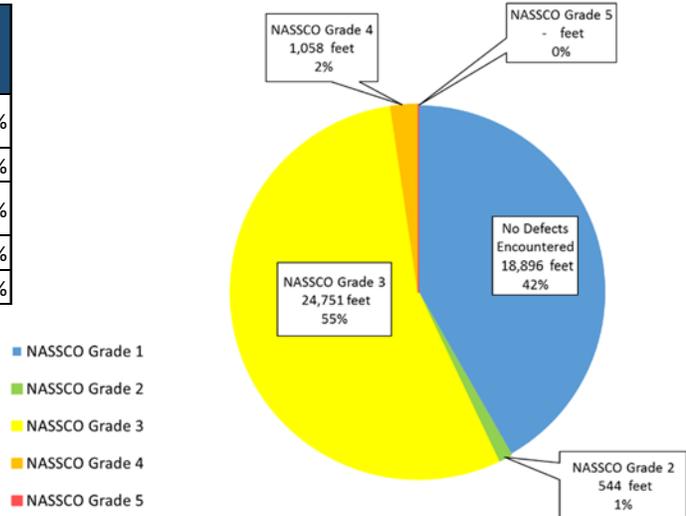
### NASSCO PACP Structural Condition Grade

Structural Defects: Approximately 43% of the pipe assessed were found to be in “Excellent or Good” structural condition (NASSCO Grade 1 or Grade 2). 55% of the pipe assessed was found to be in “Fair” structural condition (NASSCO Grade 3). 2% of the pipe assessed was found to be in “Poor” structural condition (NASSCO Grade 4). No pipe segments were found to be in “Extremely Poor” (NASSCO Grade 5) structural condition.

The majority of structural defects observed within the T-Lock Lined Concrete Pipe were lining feature defects including detached PVC lining, detached joint weld strips, lining splits, lining bulges, and lining pinholes. Four (4) structural defects including cracks and fractures were encountered in the VCP assessed.

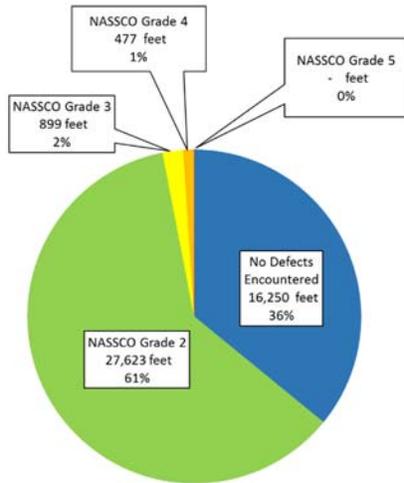
### NASSCO PACP O&M Grade

Operation & Maintenance (O&M) Defects: O&M defects are those defects that are non-structural but impede the normal operation of the pipe such as grease build up or root intrusion. No O&M defects were observed in 36% of the pipe assessed. Minor grease and encrustation deposits were noted in 61% of the pipe assessed (NASSCO Grade 2). 3% of the pipe assessed were found to be in “Fair” or “Poor” O&M condition: Two (2) pipe segments were found to have “Fair” O&M defects (NASSCO Grade 3). One (1) pipe segment was found to have a “Poor” O&M defect (NASSCO Grade 4). No pipe segments were found to be in “Extremely Poor” O&M condition (NASSCO Grade 5).
